Docket No. 217 – Development and Management Plan Inspection

Northeast Utilities Service Company Certificate of Environmental Compatibility and Public Need for the construction of a 345-kV electric transmission line and reconstruction of an existing 115-kV electric transmission line between Connecticut Light and Power Company's Plumtree Substation in Bethel, through the towns of Redding, Weston, and Wilton, and to the Norwalk Substation in Norwalk, Connecticut.

Date: March 31, 2005

Location: 345kV XLPE Component

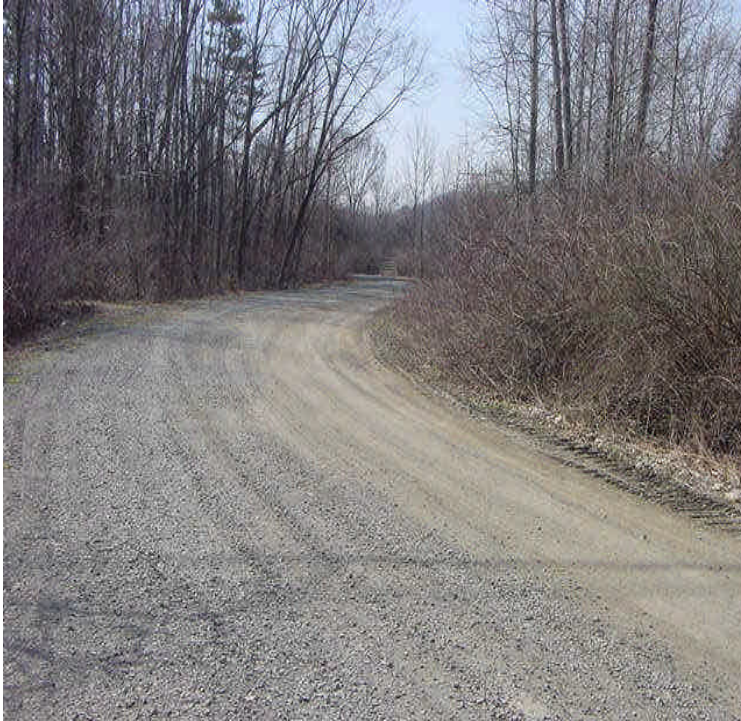
345kV XLPE (Plumtree Access Drive): Photo on the left shows a view of the access drive where the stone pile has been removed as work is complete in the area. Photo on the right shows a view of the substation in the background with the dewatering box waiting to be removed. 3/31/06

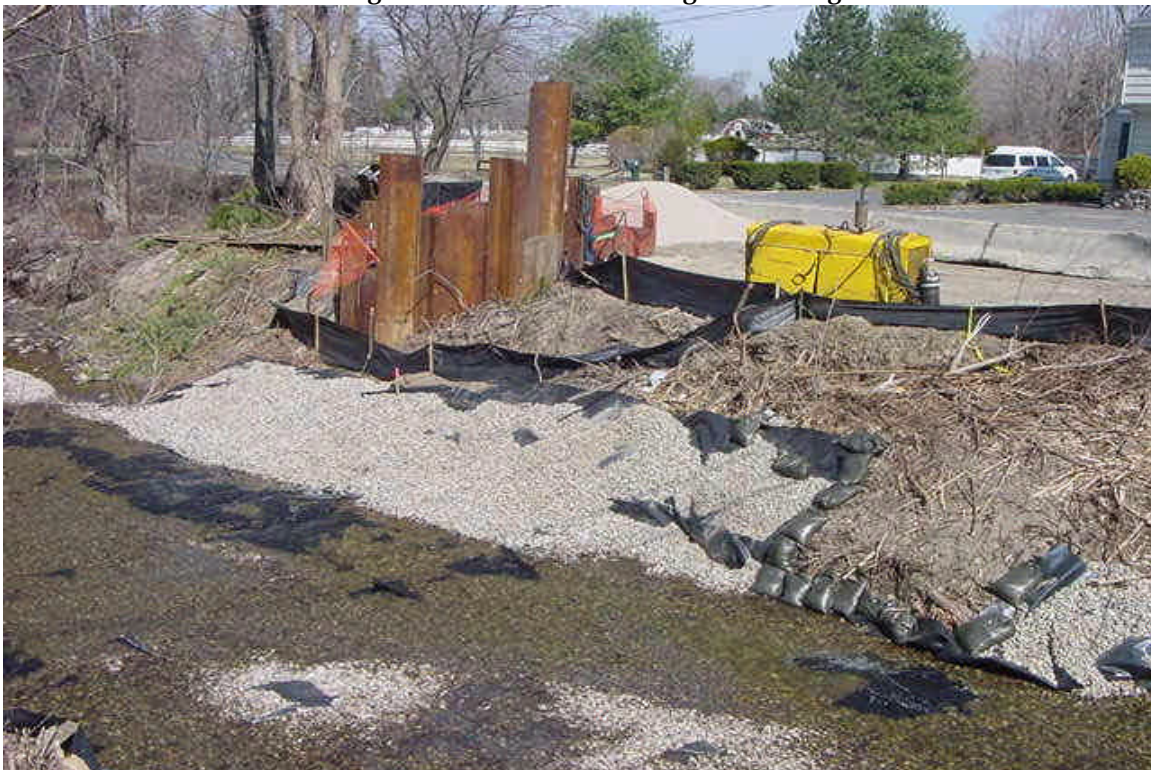
345kV XLPE (Jack and Bore): Photo shows the receiving area which also remains contained at this time. 3/31/06

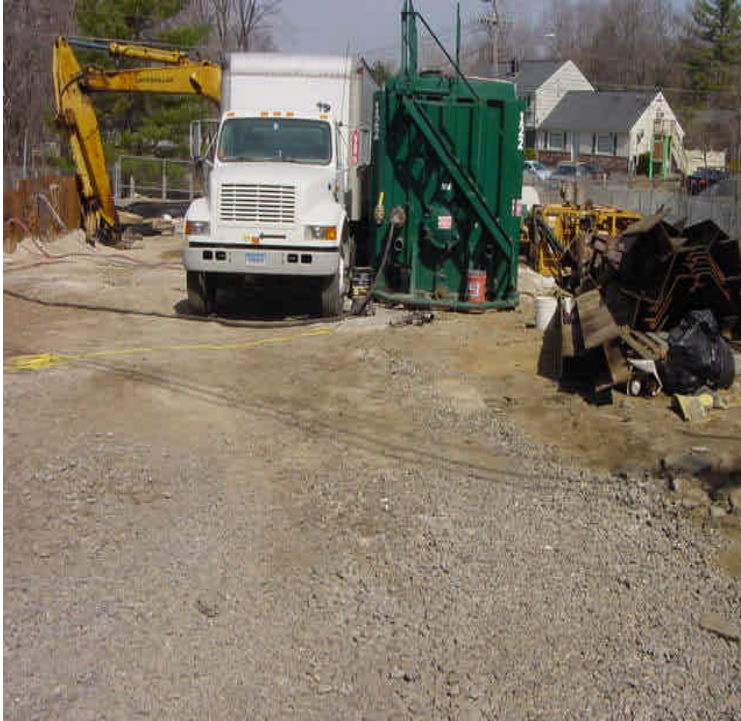
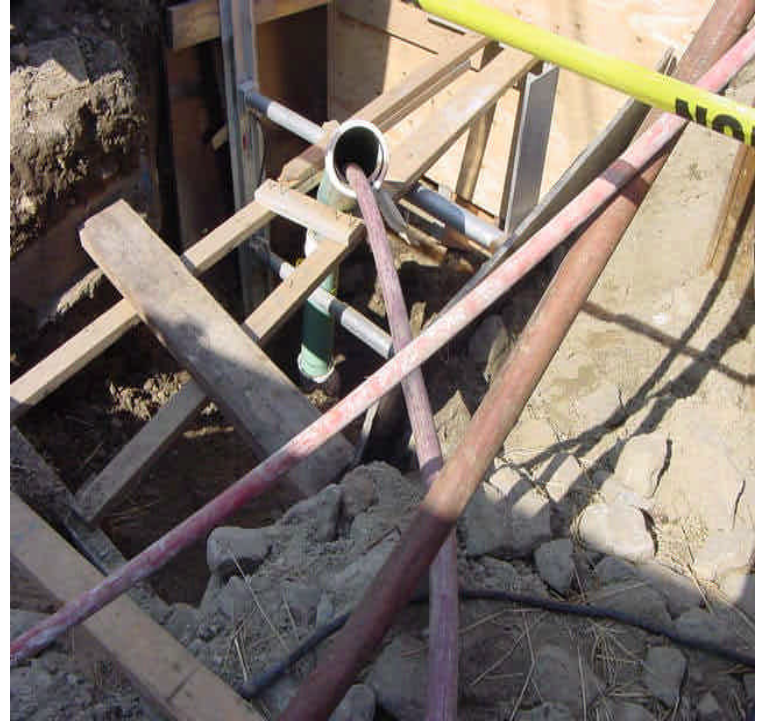
Photo on the left shows the jacking pit with a frac tank to hold water until it can be released to the municipal sewer system. Photo on the right shows the tank of well point water being emptied to the sewer system connection. 3/31/06

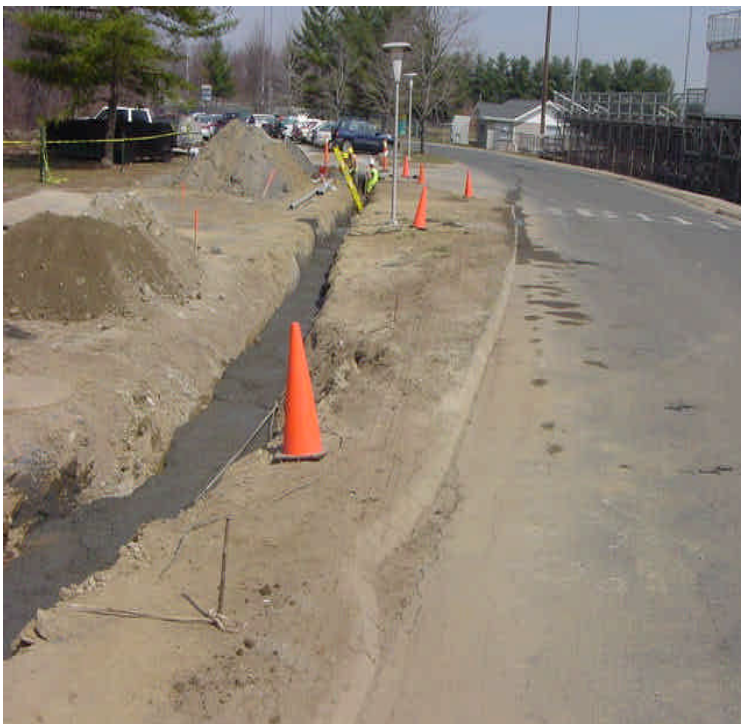
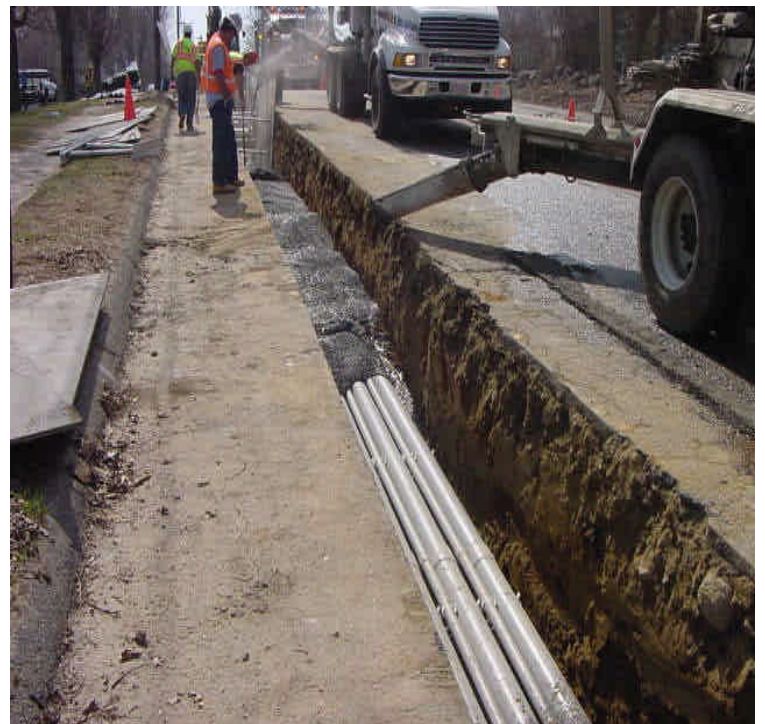
(Whittlesey Drive and Judd Avenue): Photo on the left shows trenchwork within Whittlesey Drive adjacent to the Bethel Ed. Park. Photo on the right shows trenchwork within Judd Avenue, working towards Route 302. 3/31/06

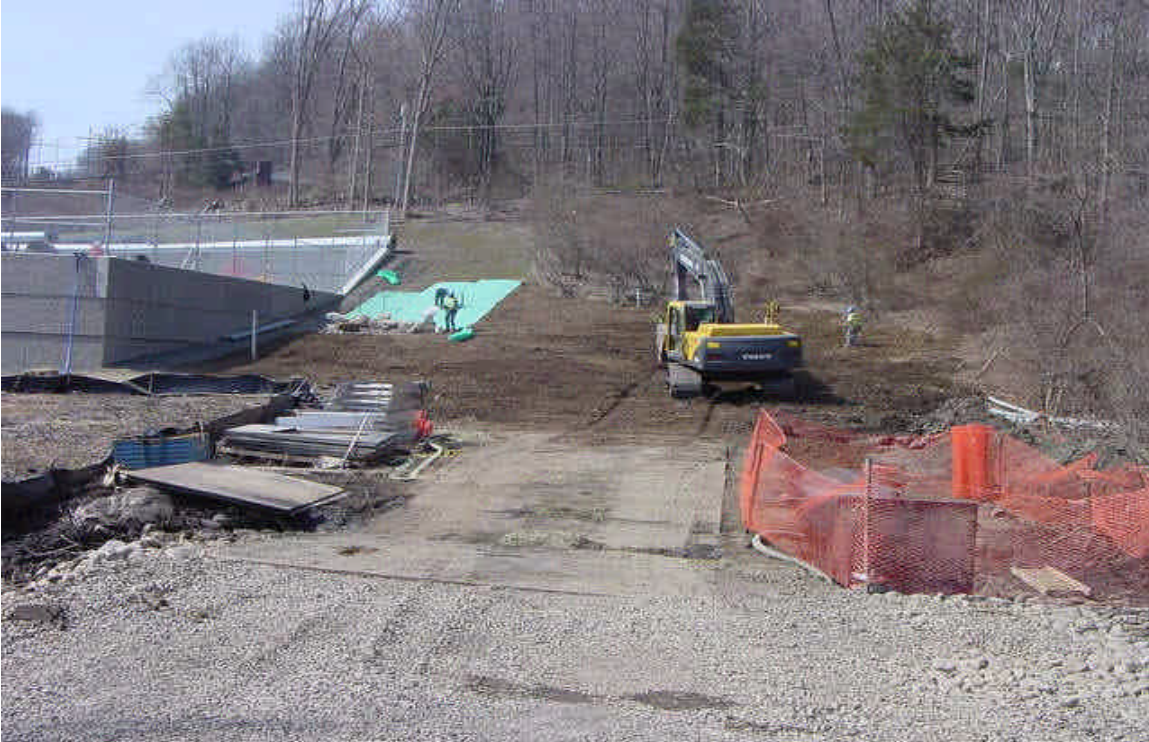
(Hoyts Hill): Photo shows an overview of the access and work at Hoyts Hill station area. Some backfilling is occurring as trenching continues towards Rt. 58. Watch placement of materials (such as trench boxes) off the mats and in the wetland. 3/31/06

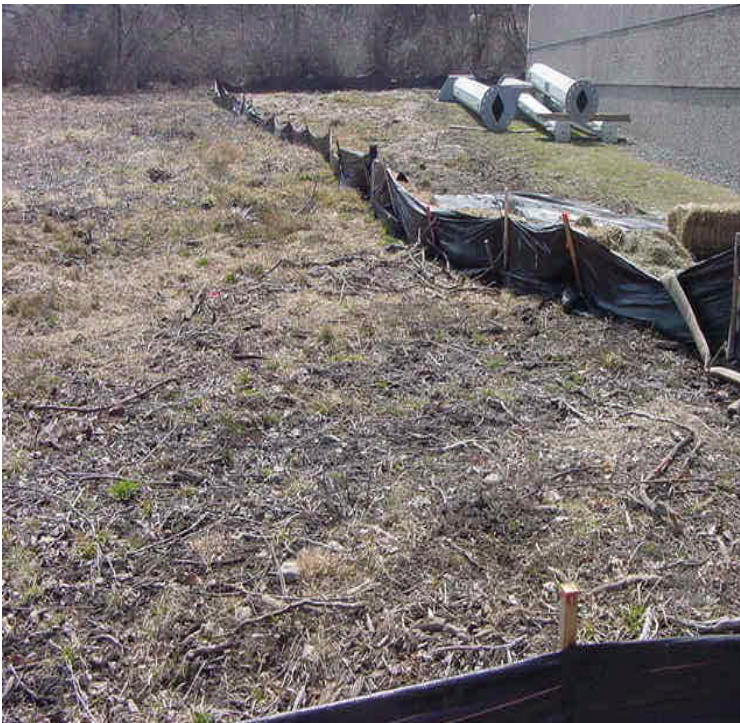
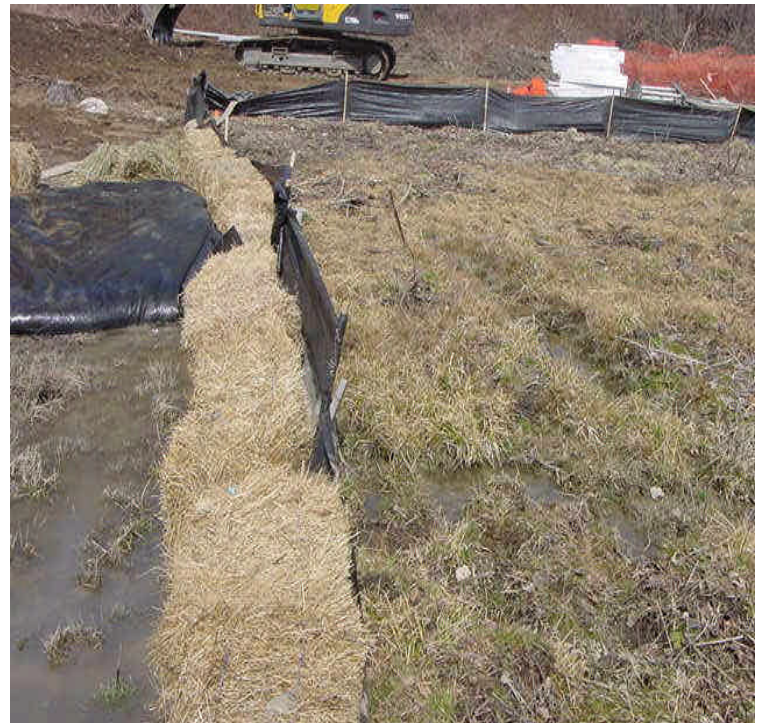
Both photos show the improved controls adjacent to the filter bag for dewatering. Previously accumulated sediment was removed from the fence and wetlands and controls were reinforced/repared. Water is being more effectively filtered. 3/31/06
